HISTORIC PROPERTY INVENTORY FORM

Field Site No. X-4 OAHP No. _____ Date Recorded 12 November 1997
Site Name Historic Railroad Tool Shed
Common Gang Car Storage
Field Recorder Holly K. Chamberlain
Owner's Name U.S. Department of Energy, Richland Operations Office
Address P.O. Box 550
City/State/Zip Code Richland, WA 99352

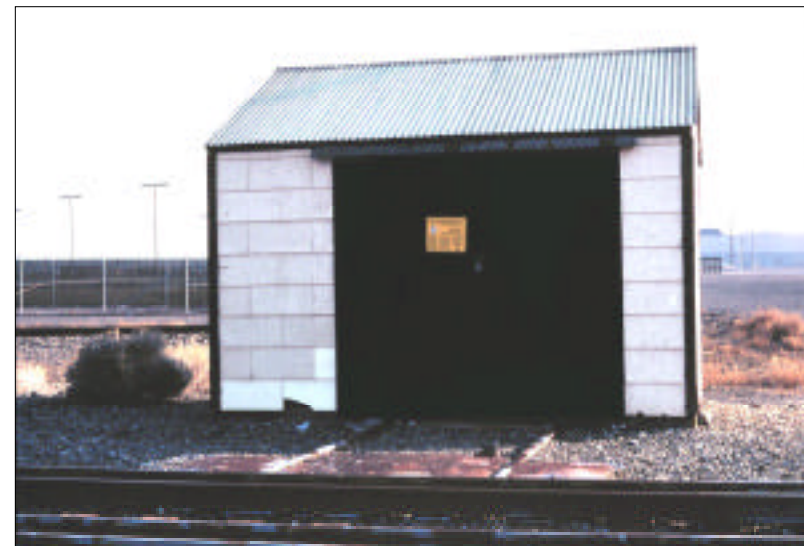
Photo at right: Roll 379, Frame 17
View of west elevation

Located east of and adjacent to the north-south railroad tracks in the 1100 Area west of the 1170 Building and south of the 1171 Building, the rectangular wood-framed X-4 Building is set upon a wood foundation. It is sheathed in asbestos shingles, which were applied over earlier asphalt siding. The exterior walls have wooden corner boards. Oriented along a north-south axis, the gable roof is covered with corrugated metal roofing, which was applied over an earlier material. There is a short metal gutter over the doorway at the roofline. The one entrance is located on the west side, and occupies most of the facade. It has double wooden doors with large hinges which open outward. A short set of railroad tracks run from the doorway to the adjacent rail siding. The handcar could be pulled along the tracks to be lifted onto the tracks of the siding.

The building measures approximately 10 feet by 20 feet. It is presently empty.
